Experimental investigation of impact behavior of wood-based sandwich structures

John Susainathan, Florent Eyma, Emmanuel De Luycker, Arthur Cantarel, Bruno Castanie*

Institut Clément Ader (ICA), Université de Toulouse, CNRS UMR 5312-INSA-ISAE-Mines Albi-UPS, Toulouse, France

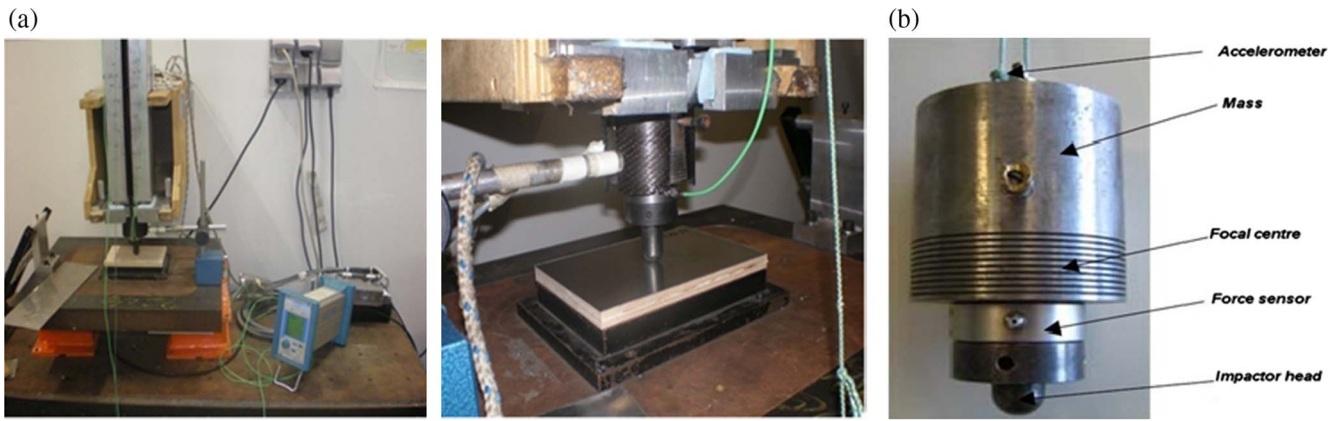
Impact tests were performed using a drop weight apparatus (Fig. 2) followed by tomography analysis. The principle of the falling weight is to drop an instrumented mass, guided in a tube, onto a sample plate held by a clamping window. In our test, the main components were:

- A mass of 2.08 kg. This value was set so as to achieve the desired impact energy with speeds of up to 5 m/s;
- A load sensor located under the mass, to measure the force between the impactor and the specimen during the impact;
- A hemispherical impactor 16 mm in diameter;
- An optical sensor measuring the speed of the impactor immediately before impact;
- A support window, of internal dimensions 125 × 75 mm², on which the specimen was positioned (standard specimen dimensions: 100 × 150 mm²). These dimensions were determined based on Airbus standards AITM 1-0010;
- A clamping window having inner dimensions identical to those of the lower window (125 × 75 mm²) to hold the specimen during the impact;
- A kickback system to prevent multiple shocks on the specimen (same as in [24]).

Fig. 2. (a) Drop-weight impact test set-up and aluminum wood specimen installed, (b) Impactor head. (For interpretation of the references to colour in this figure legend, the reader is referred to the web version of this article.)

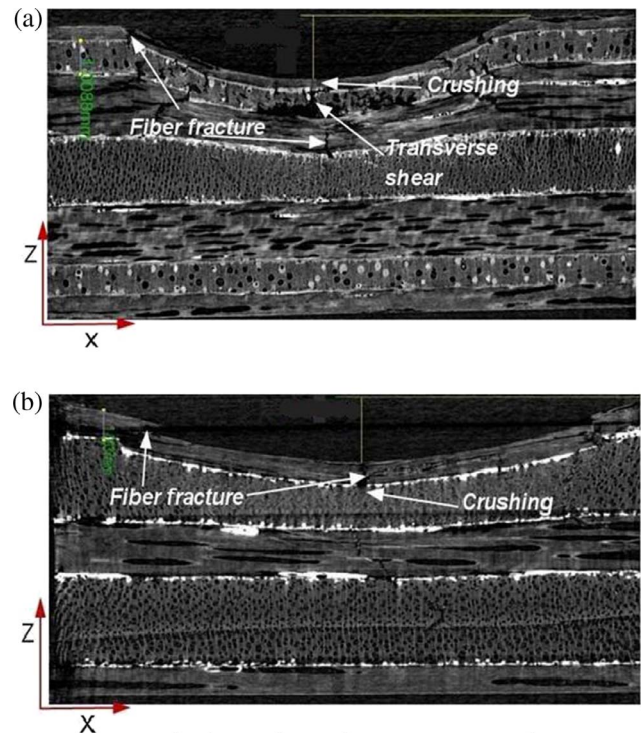
Fig. 3. Failure modes of impacted plywood core at 10 J. (a) Plywood A, (b) Plywood B. (For interpretation of the references to colour in this figure legend, the reader is referred to the web version of this article.)

Firstly, it was observed that crack initiation always occurred in the plywood close to pre-existing damage in the plywood. These pre-existing damages are due to the peeling cutting process used to obtain wood plies from the log. This process generates pre-cracks in the radial/longitudinal plane that may propagate in the same direction or rotate to propagate in the tangential/longitudinal plane because of transverse shear [31]. A tomography analysis on damaged samples of plywood A and B is shown in Fig. 3(a) & (b). In the case of plywood structures, a permanent indentation occurred at all energy levels through deformation due to plasticity or fracture of wood ply. Maximum deformation occurred at the top ply due to crushing. Only one third of the sample was concerned at 5 J but permanent deformation occurred in up to one half of the sample for a 10 J impact test. For 15 J tests, perforation occurred and the impactor hangs in the plywood which creates the

second peak. In summary, for both plywoods (A and B), we identified fiber fracture, transverse shear, crushing, permanent indentation and deformation as predominant failure modes, with propagation to one half of the plywood core with increasing energy levels.

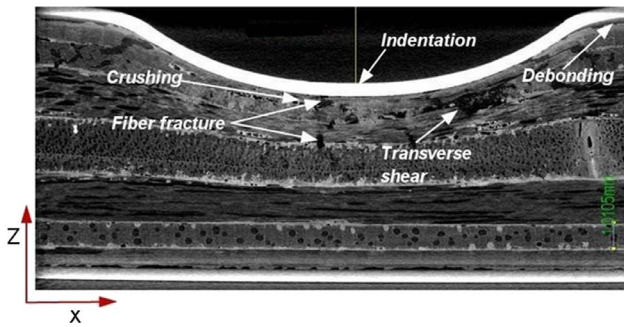
Fig. 5. Tomography images of impacted plywood with aluminum skin – Failure modes at 15 J. (For interpretation of the references to colour in this figure legend, the reader is referred to the web version of this article.)

With aluminum skins, a permanent indentation was observed for all impact energies due to the ductile property of this material and the smaller elastic spring back effect as shown in Fig. 5. Delamination between skin and core was not observed under the impactor but very slightly around it. In the case of 5 J impact, crushing, fiber fracture and transverse shear were observed in one third of the depth of the plywood core, i.e. down to the top okoume 0° ply. At 10 J, the same failure modes were observed on half the depth of the plywood core, down to the poplar 0° ply. At 15 J, the delamination and damage area increased

around the impactor. The same phenomenon as above, with maximum deformation, occurred down to two thirds of the depth of the plywood core, i.e. to the middle poplar 90° ply in plywood – A, as shown in Fig. 5.

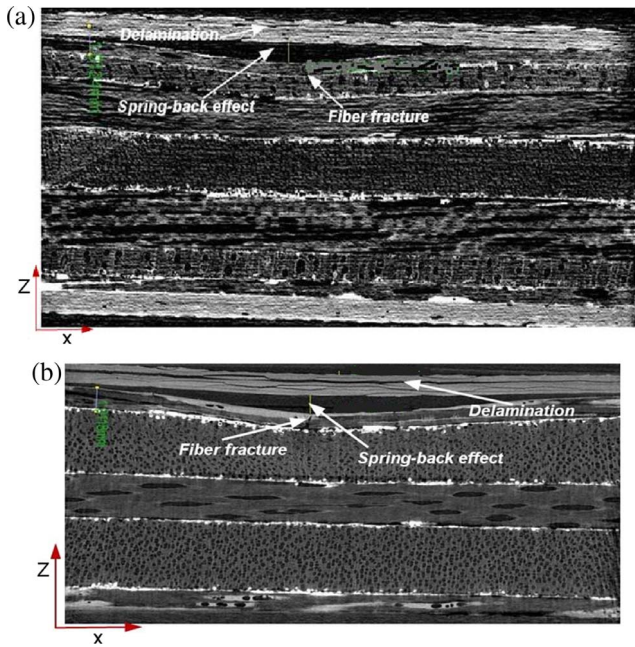
Fig. 7. Tomography images of impacted plywood with Carbon skins – Failure modes at 15 J, (a) plywood A, (b) plywood B. (For interpretation of the references to colour in this figure legend, the reader is referred to the web version of this article.)

With carbon fiber composite as shown in Fig. 7 a and b, small permanent indentation was observed under the impactor and top carbon skin, due to crushing of the core and elastic spring back of the skin. It also caused indentation and a damage area on the ply below the

top skin. The amount of damage and indentation area on the top skin were lower than in the wooden ply below the top skin. At 5 J, delamination was observed in the carbon fiber composite skins and at the interface between the core and the skin. Fiber fracture and crushing were observed in the top fifth of the plywood core. At 10 J, delamination inside the skin and between the impacted skin and the core increased. Crushing, fiber fracture and deformation were observed in a quarter of the depth of the plywood core, down to the top okoume 0° ply. At 15 J, all the above failure modes spread into the top third of the plywood core, down to the top poplar 90° ply in plywood - B (see Fig. 7b).

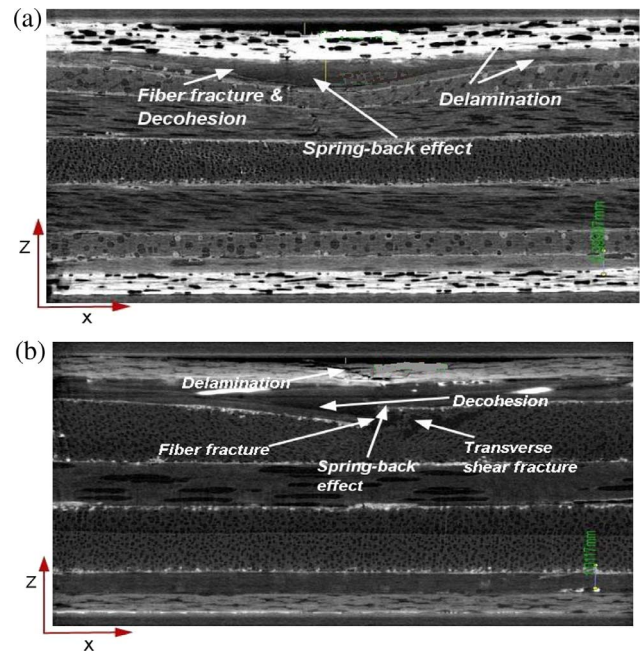
Fig. 8. Tomography images of impacted plywood with glass skins – Failure modes at 15 J, (a) plywood A, (b) plywood B. (For interpretation of the references to colour in this figure legend, the reader is referred to the web version of this article.)

With glass fiber reinforced composite skins as shown in Fig. 8 a and b, the phenomena were quite different, with no delamination between the top skin and the core, thanks to their perfect adhesion. The delamination thus occurred at the ply below the top skin. Elastic spring back of the composite skin also caused damage at the poplar 90° ply and fiber fracture at the top okoume 0° ply below the skin, which led to higher deformation at the third ply from the top (poplar 90°) than at the second one. At 5 J, slight indentation and crushing occurred under the impactor, delamination and fiber fracture were observed in the glass fiber skin, and fiber fracture was observed in one tenth of the plywood

core, i.e. in a quarter of the cross section. In the case of 10 J, crushing occurred in a one quarter of the plywood core, delamination was observed between the skins and the core, but fiber and transverse shear fracture occurred in one quarter of the plywood core, down to the top okoume 90° ply. At 15 J, fiber fracture occurred in the composite skin, and transverse shear, crushing and maximum deformation occurred in one third of the plywood core, down to the top poplar 0° ply in plywood A (Fig. 8a & b).

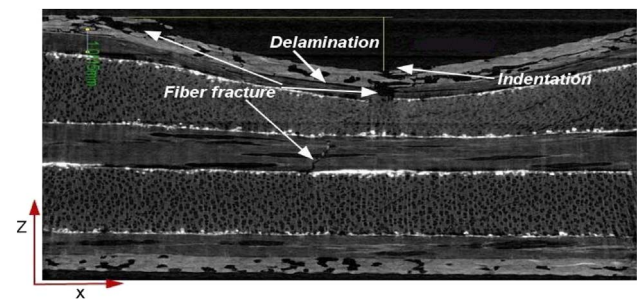
Fig. 9. Tomography images of impacted plywood with flax skins – Failure modes at 15 J, plywood B. (For interpretation of the references to colour in this figure legend, the reader is referred to the web version of this article.)

Considering flax fiber reinforced composite skins, the damage modes were slightly different, as shown in Fig. 9. At 5 J, delamination between the skin and the core, and moderate indentation occurred under the impactor due to elastic spring back of the composite skin. Fiber fracture was observed on the one tenth of the plywood core, down to the top okoume 0° ply, while crushing appeared on one third of the plywood core, down to the top poplar 90° ply. In the case of 10 J, delamination increased under the impactor, crushing was observed on 40% of the plywood core (down to the top poplar 90° ply) and fiber fracture appeared in the flax composite top skin. At 15 J, fiber fracture and indentation was found in one half of the depth of the plywood core, down to the middle okoume 0° ply in plywood B. Delamination increased and fiber fracture occurred in the flax skin.

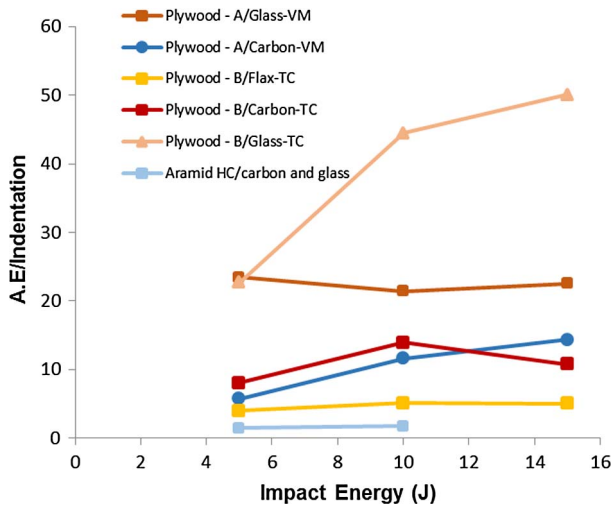
Fig. 11. Ratio of absorbed energy to indentation for plywood with composite skins (J/mm). (For interpretation of the references to colour in this figure legend, the reader is referred to the web version of this article.)

Regarding energy absorption and indentation, the impact responses of plywood with composite skin at 5 J, 10 J and 15 J in terms of force vs displacement and ratio of absorbed energy to indentation are shown in Fig. 10 and also in Table 5. In the case of carbon skins, the higher stiffness of the skins and the lack of internal damages resulted in small indentation and the smallest absorbed energy as shown with sharp shapes of the curves. This composite also resisted the highest impact load but with more delamination in the skin and extreme crushing of the plywood core due to its elastic spring back and the poor adhesion attained in the case of vacuum molding, where air can be trapped during vacuum creation. Regarding the glass fiber skins, absorbed energy was comparable to that for flax, with also a smaller indentation than for carbon because of the higher strength of the skins and perfect adhesion obtained with the samples manufactured by thermo-compression as compared to plywood with carbon skin manufactured by both vacuum molding and thermo-compression. Despite a lower indentation than for the reference material, the ratio of absorbed energy to indentation (Fig. 11) was not much higher for the flax composite skin structure.

The ratios of absorbed energy to indentation are plotted in Figs. 4(d), 6(d) and 11 and are noted in Tables 3–5. The specific energy

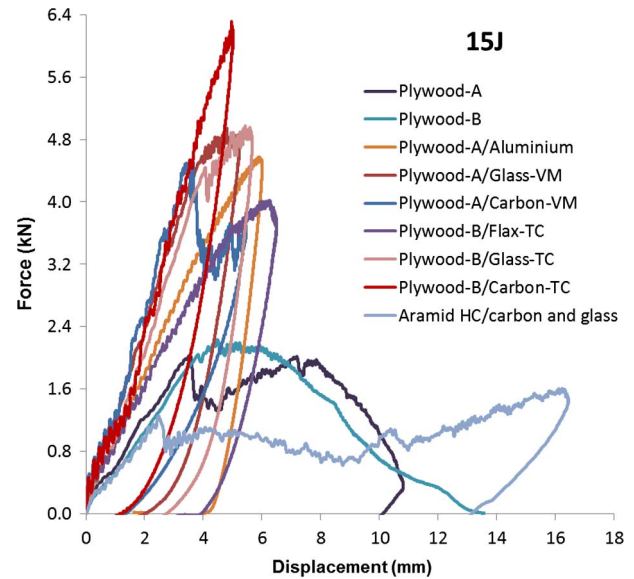
Fig. 12. Force-displacement plot for the different wood based sandwich structures at 15 J. (For interpretation of the references to colour in this figure legend, the reader is referred to the web version of this article.)

The impact response of the eight different wood based sandwich structures and our reference materials are presented in Fig. 12 in terms of a force-displacement plot for the 15 J case only. In general, the initial slope of force-displacement varies with the skin materials, thus indicating variation in stiffness of the different wood based sandwich structures. As expected, the skin properties influence the impact behavior of these sandwich structures even at lower displacement values. Concerning plywood structures, plywood A is found to yield slightly better results than plywood B in terms of absorbed energy and indentation, due to its longer plateau. Its higher number of interfaces causes better transverse behavior, which leads to smaller permanent indentation than in plywood B. Both plywood structures have comparable energy absorption capabilities and lower indentation in comparison to the reference material (see Tables 3–5). In terms of specific energy absorption, despite the good results of the materials under test, the reference material yields the highest results due to its low density. However, at 15 J, all these materials undergo perforation with heavy loss of structural integrity, which are incompatible with most applications. The plywood also gives good results regarding specific energy absorption because of its low density.

For plywood structures with aluminum skins, compared to plywood structures alone, there is an absence of plateau and peak force oscillation occurs due to the high strength and stiffness of the skin. This structure has comparable energy absorption and better resistance to indentation than the reference material but is not as good in terms of specific energy absorption, because of the high density of aluminum skin. Moreover, this structure results in a deeper indentation than in any of the other structures with composite skin, which can be undesirable in some applications.

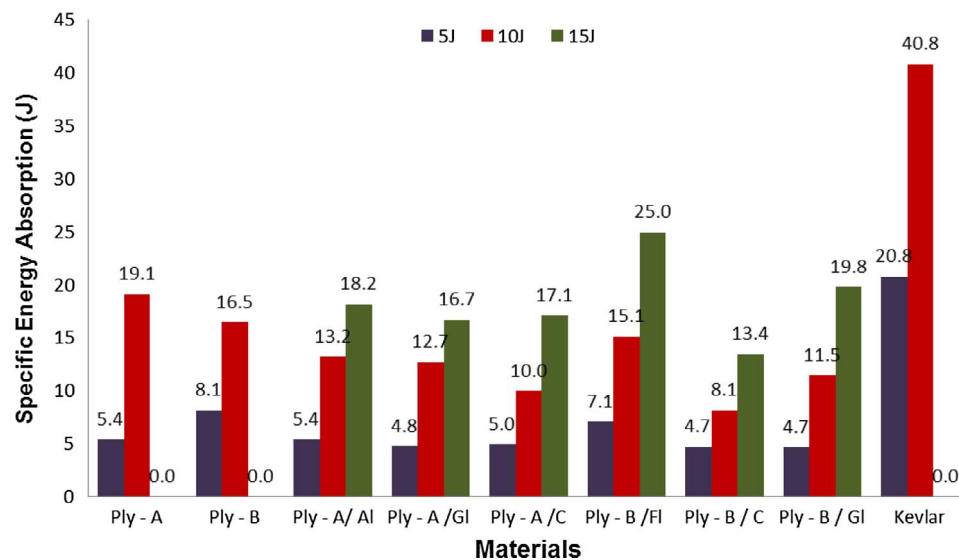
Fig. 13. Specific energy absorption for the 8 configurations tested plus the reference one. (For interpretation of the references to colour in this figure legend, the reader is referred to the web version of this article.)

absorptions at three energy levels for different sandwich structures are shown in Fig. 13. Two different processes, thermo-compression and vacuum molding with prepreg, were used to manufacture our panels of plywood structure with carbon/epoxy and glass/epoxy composite skins. In general, we found that the plywood with glass skin fabricated by the thermo-compression process had minimum defects, and better adhesion and structural integrity than that obtained by vacuum molding, as a result of the high operating temperature, the absence of trapped air, and the pressure used in the thermo-compression process.

Finally, regarding specific energy absorption (see Fig. 13), the reference material, aramid honeycomb with carbon and glass composite skins, yields the highest results because of its low density but undergoes perforation and loses its structural integrity for high energy impacts (15J). In comparison, in the case of plywood with aluminum skin, crushing is transformed into indentation without perforation. Regarding newly developed wood based sandwich structures; a very
